Strength Determination of "Tooth-Paste" Like Sand and Gravel Washing Fines Using DMT

HDR Engineering, Inc.

ABSTRACT: An approximately 18 acre (0.1 km²) site was proposed for a Confined Dike Facility (CDF) for the disposal of dredged materials. Based on available information the site was believed to be located on natural ground. During the initial investigation, the site was found to be located on top of a slurry pond that had been covered with fill. The slurry pond was previously used for the disposal of slurried fines "washings" from sand and gravel processing. The washings had the consistency of "toothpaste", even after having been covered with fill for at least 14 years. The initial investigation used Standard Penetration Tests (SPTs) and Shelby tubes to obtain samples, since the materials at the site were expected to be a natural deposit. Two types of washings were encountered – "clayey washings," which were primarily clay; and "sandy washings," generally consisting of sand with various amounts of clay, gravel and silt. The clayey washings were an almost pure clay and had pocket penetrometer values of 0 tsf (0 kPa) even with the special foot attachment for very soft soils. La

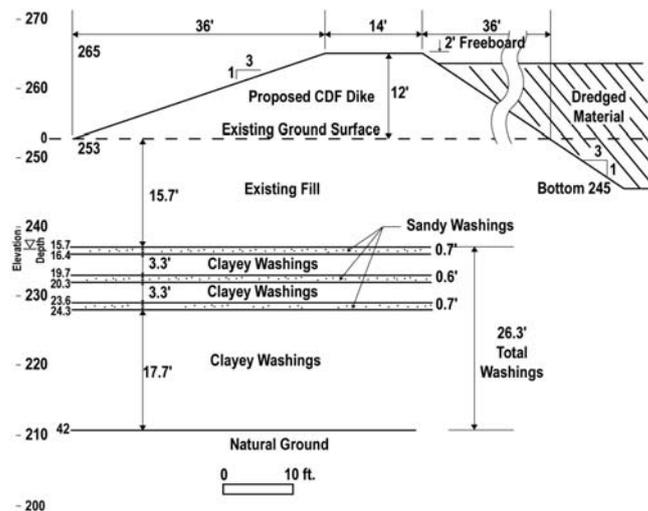
Figure 3. Typical CDF Section at Dilatometer Sounding B-12

An assessment of the long-term settlement of the full CDF dike section at the edge of the field/pond area was performed using boring and laboratory data. The stratigraphy was based on Boring B-12, in which dilatometer soundings were taken at 8-inch (20.3 cm) intervals, resulting in a complete profile of the washings, as shown in Figure 3. The fill overlying the washings was considered relatively incompressible under the CDF dike load, based on its being a dense granular material. The underlying washings were about 26 feet (7.9 m) thick. As shown in Figure 3, the washings consisted of clayey washing separated by several layers of sandy washings. Relatively incompressible natural soils, consisting of clayey silt, were encountered below the washings. Long-term settlement was estimated for each of the clayey washings layers. Consolidation settlement was estimated to be about 15 inches (38.1 cm) at this location. However, the magnitude of settlement across the site could vary due to variations in the thickness and pre-loading of the washings and other factors such as dike staging and rate of construction. Immediate settlement due to compression of the sandy layers in the washings should occur during construction. In addition, some additional long-term settlement could occur due to the weight of the dredged materials.

Due to the low strength of the materials underlying the CDF, the results of the analyses indicated that the dike needed to be constructed in stages to achieve the targeted minimum factor of safety and set back from the edge of the pond area. The first stage dike was made to be approximately half the size of the full dike. The analyses also indicated that a geogrid-reinforced buttress was needed in the pond area prior to construction of the full dike. Construction of the first stage dike would allow some strength gain in the materials underlying the dike due to consolidation. Staging

of dike construction also allowed for dredging operations to begin so that sand could be generated for use as a buttress in the pond area prior to constructing the Stage 2 dike. In a portion of the field area, the interior dike slopes had to be flattened to 6H:1V and the floor of the CDF raised due to the presence of washings at shallow depths.

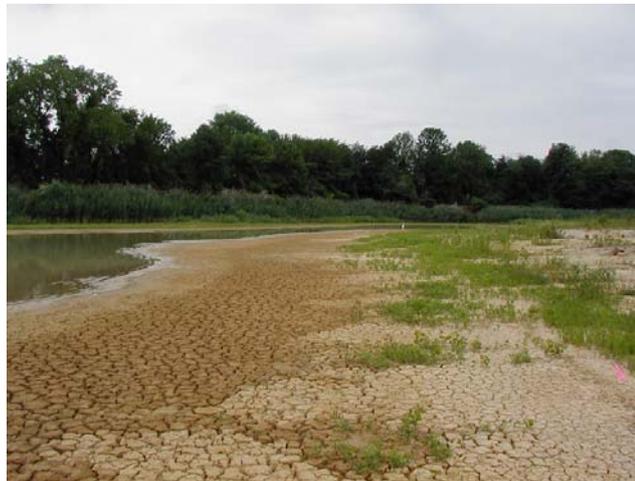
Figure 4. Desiccation cracks in Pond 1 area looking toward slurry pond dike.

Desiccation cracks extended to depths of several feet in the Pond 2 area. Borings B-2, B-4, and B-6 were drilled around the perimeter of

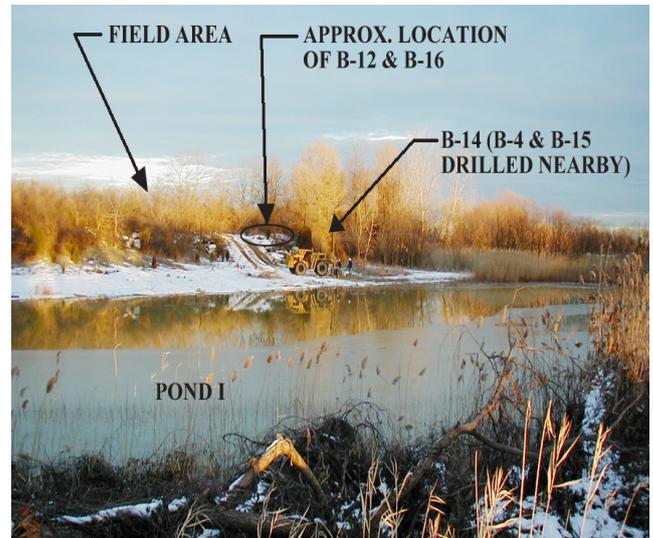
Figure 5. Approximate boring locations in Pond 1 area. View from slurry pond dike.

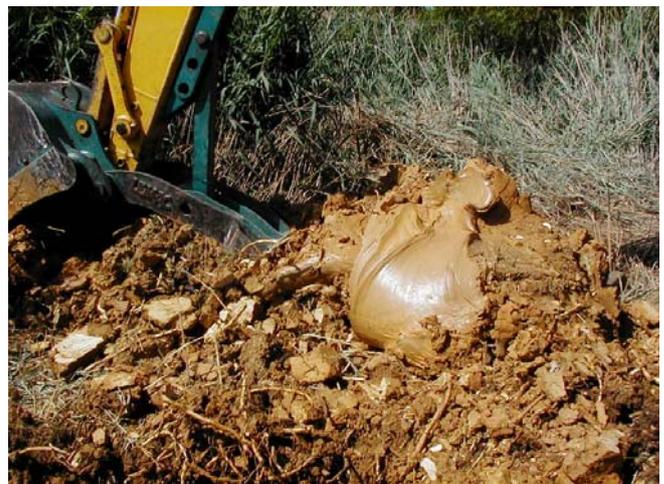
Figure 6. Hard, desiccated and soft, wet clayey washings at Test Pit 4

Test pit TP-4 was excavated at the edge of Pond 2. It encountered clay washings, which were hard and blocky due to desiccation in the upper 2 feet (0.6 m) and became softer with depth to 5 feet (1.5 m), where it became very soft (Figure 6). The moisture content increased with depth and was wet at 5 feet (1.5 m).

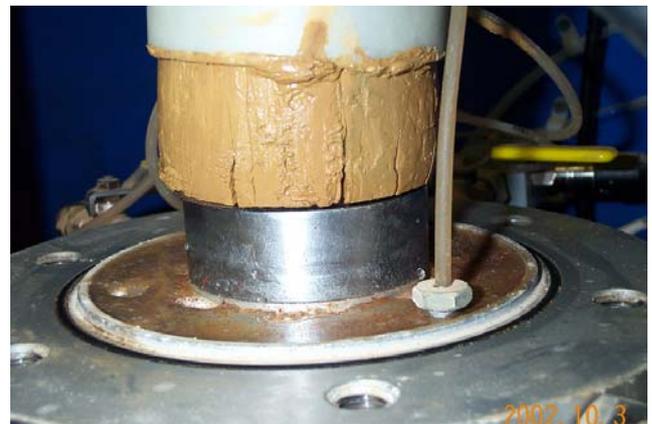
Strength testing was attempted on undisturbed samples of clayey washings obtained in the initial investigation, but the sample started to expand and crack as it was being taken out of the tube as it was opened and was, therefore, not suitable for testing (Figure 7). Consolidation tests were performed on two undisturbed samples of the washings obtained in the initial investigation. The testing indicated that the Compression Index (c_c), was 1.1; the Coefficient of Consolidation (c_v) varied from 0.0213 to 0.0568 in²/min (13.7 to 36.6 mm²/min), the Initial Void ratio, e_0 , was 3.1077, the wet unit weight was 93.5 pcf (1500 kg/m³), and the preconsolidation pressure was 575 psf (27.5 KPa at

Figure 7. Sample of clayey washings expanding due to lack of confinement during extrusion from Shelby Tube.

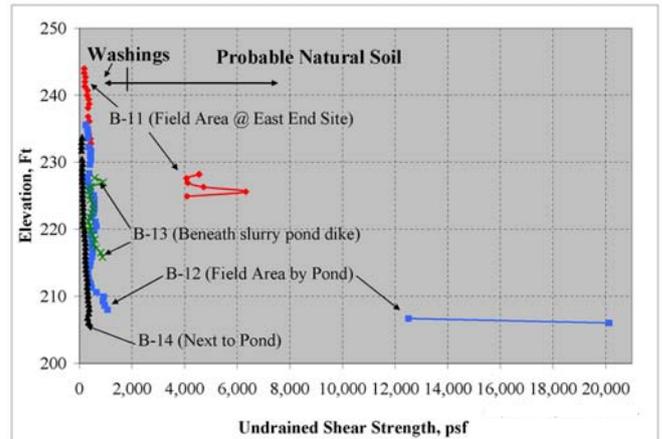
Figure 9. In-place undrained shear strength of all soils by DMT. (Note: Gaps in data indicate granular material)

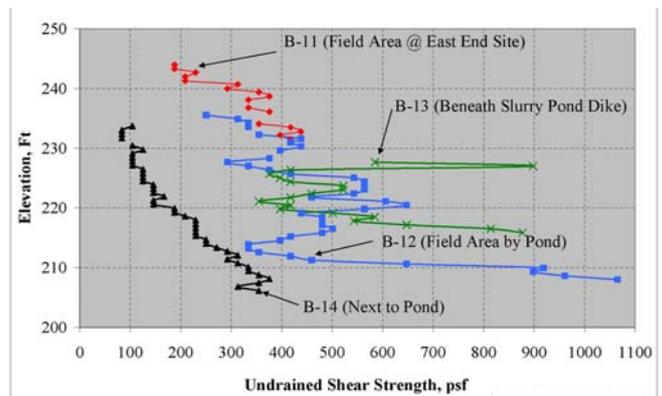
B-11, B-12, B-13, and B-14, while Figure 10 only provides data on the washings, since their strength is much lower than that of the natural soils. Figure 10 indicates that higher strengths are present in washings that have been covered by fill or underlie the dike (B-11, B-12, and B-13) than the washings with minimal overlying fill (B-14). The figure also indicates that there is generally some strength gain with depth, which is likely due to normal consolidation. DMT results for Boring B-14, in particular, exhibit this trend.

Figure 10. In-place undrained shear strength of washings by DMT. (Note: Gaps in data indicate granular material)

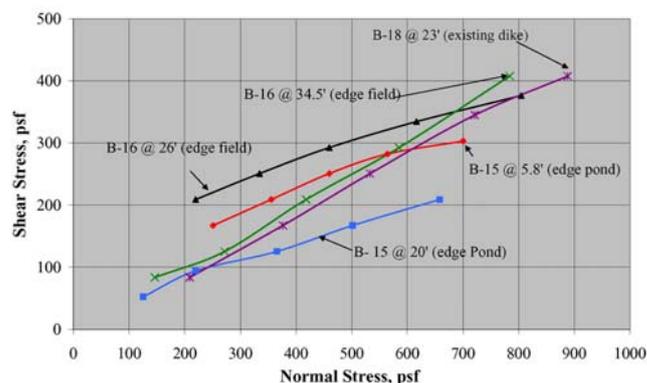
Figure 13. In-place drained shear strength of washings determined by borehole shear test.

are generally parallel to each other but are not parallel to the envelopes for B-16 at 34.5 feet (10.5m) and B-18 at 23 feet (7.0 m). This may be due to variations of the washing materials since the first group exhibit cohesion and the second group has no cohesion. Curvature of the strength envelopes of B-15 at 5.8 feet (1.8 m) and B-16 at 26 feet (7.9 m) are also present at higher loadings. Strength parameters adopted for design are indicated in Table 2.
