Long-Term Settlements of an Avalanche Gallery on Loose Soil

ABSTRACT: An avalanche protection gallery built 1984 to 1985 on the Gotthardpass road in the central Swiss Alps suffered substantial settlement of several decimeters. The causes were determined by additional site investigations during 1987 utilizing the Marchetti Flat Dilatometer DMT (Steiner, 1994). Since construction 30 years have passed and the road and its structures have undergone a complete inspection and will be reconditioned. Within this long-term maintenance project the settlement behavior of the avalanche gallery has been reevaluated and the monitored settlements have been compared to the prediction from 1987. The settlement and deformations have followed a semi-logarithmic law with time, but differential settlements have changed. The value of the DMT measurements can be confirmed by these long-term measurements.

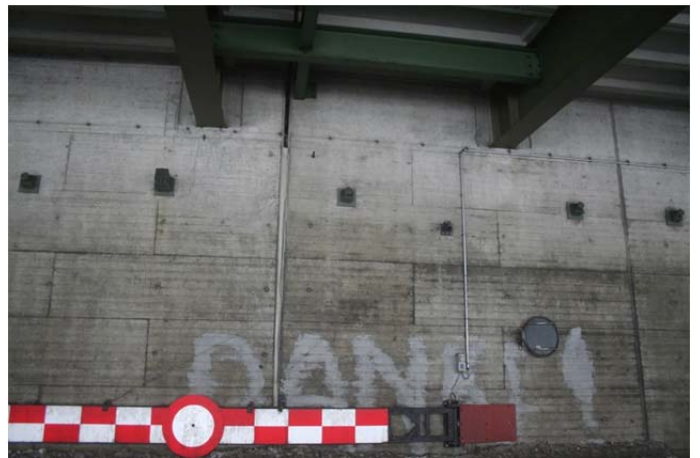
The separation of the back wall by a dilation joint between two segments of the gallery is shown on Fig. 6; there the longitudinal differential settlement between the two sections of the retaining wall is clearly visible by the different inclination. Dilation joints of 50 mm were placed every 25 m, the reinforced foundation beam runs continuously below the wall.

Fig. 6. Retaining wall with open joint due to differential settlement and heads of tiebacks placed.

In 2002 additional tiebacks had been placed in the retaining wall to support loads based on modified load requirements (Fig. 6, Fig. 7).

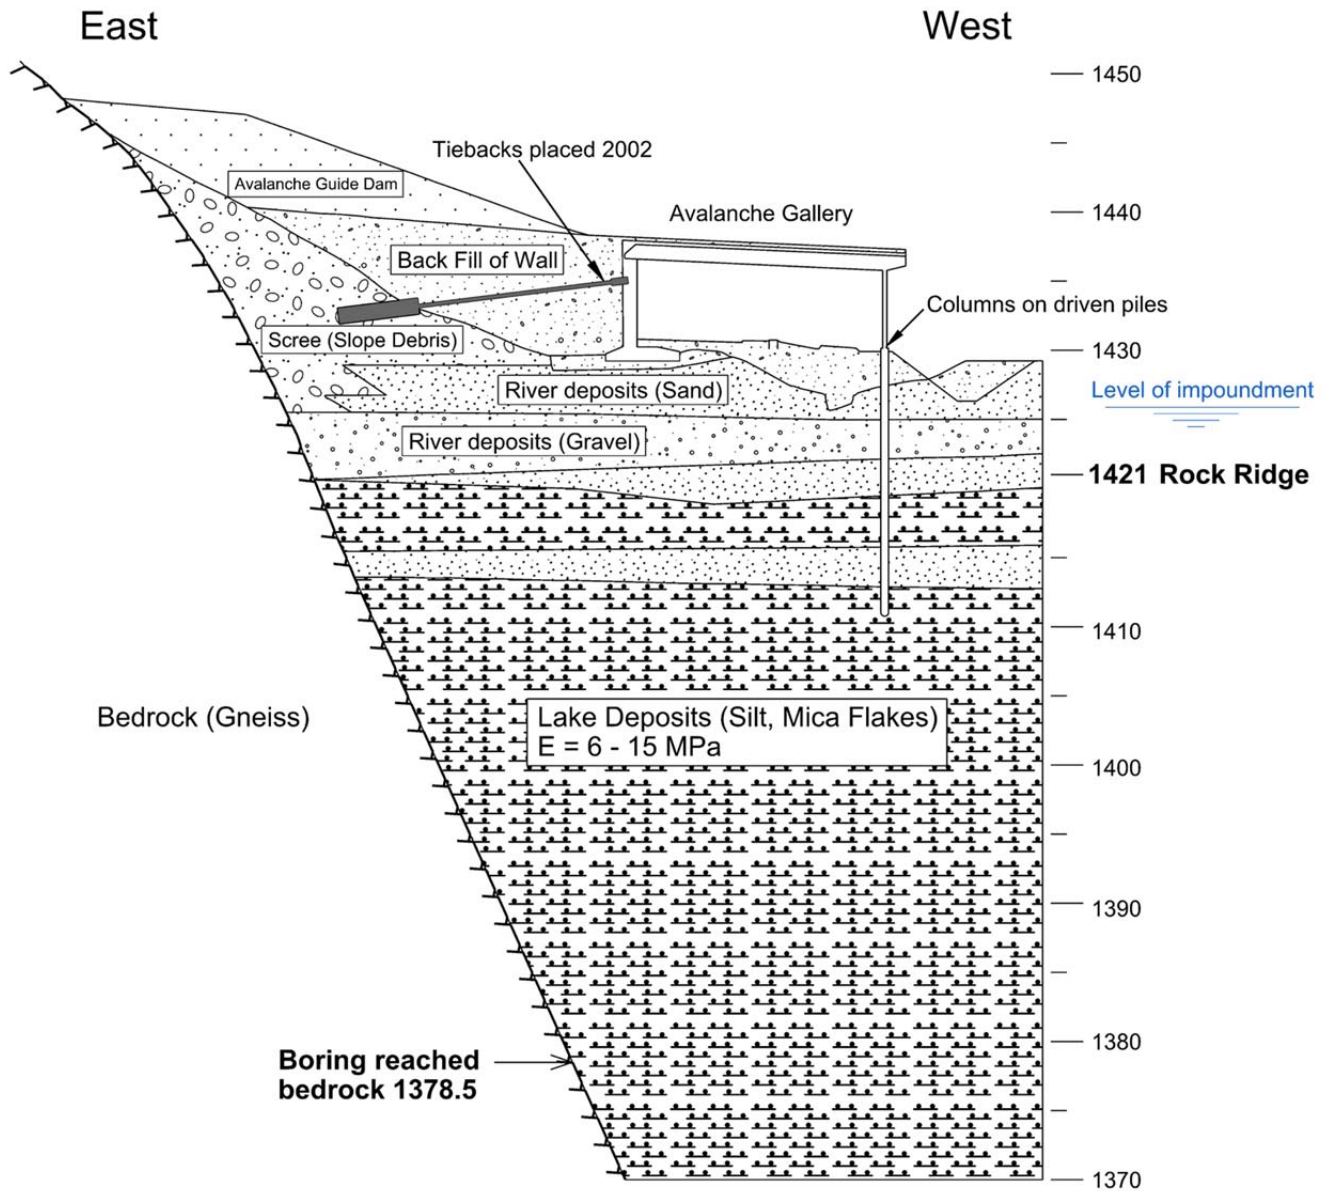
The subsoil conditions below the gallery consist of 10 meters of fluvial gravel and sands underlain below the retaining wall by 43 m of loose silt and sandy silt. The steeply dipping (Fig. 7) bedrock surface had been encountered at elevation 1378.5 m. The depth of the sediments below the columns is not known.

Behind the avalanche gallery slope debris had accumulated. The zone between retaining wall and slope debris was backfilled. At the southern end of the gallery a retaining dam was placed that deflects the avalanche over the gallery away from the portal. Backfill and dam created a surcharge on the subsoil their effect spreads laterally.

Fig. 7. Cross section with conditions of underground and backfilling at the southern end of the avalanche gallery.

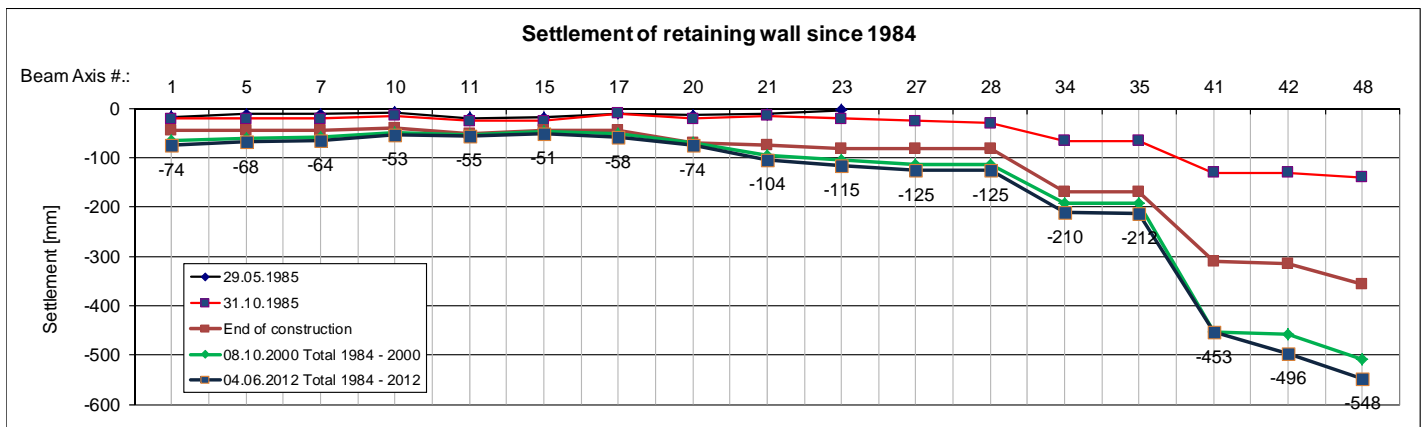
The compiled settlements along the back retaining wall are presented in Fig. 8. and for the columns in Fig. 9. The first measurements of the settlement of the retaining wall were carried out on May 29, 1985, when only the northern part of the wall was complete. The second measurements presented from October 31, 1985 indicate settlements of the southern end of 120 mm and the different behavior of this part of the construction. At the end of construction settlement had reached 350 mm. These observations led then to the decision to carry out additional site investigation (Steiner, 1994) applying the flat dilatometer DMT.

Settlements continued as extrapolated and the settlements reached 550 mm during 2012, an increase by 50 percent since end of construction, equivalent to the predictions carried out in 1988. Settlements of the footings of the columns have reached 300 mm in 2012 (Fig. 9) and had nearly doubled since the last measurements after construction.

Fig. 8. Settlements of back wall of avalanche gallery from north to south, from 1984 until 2012

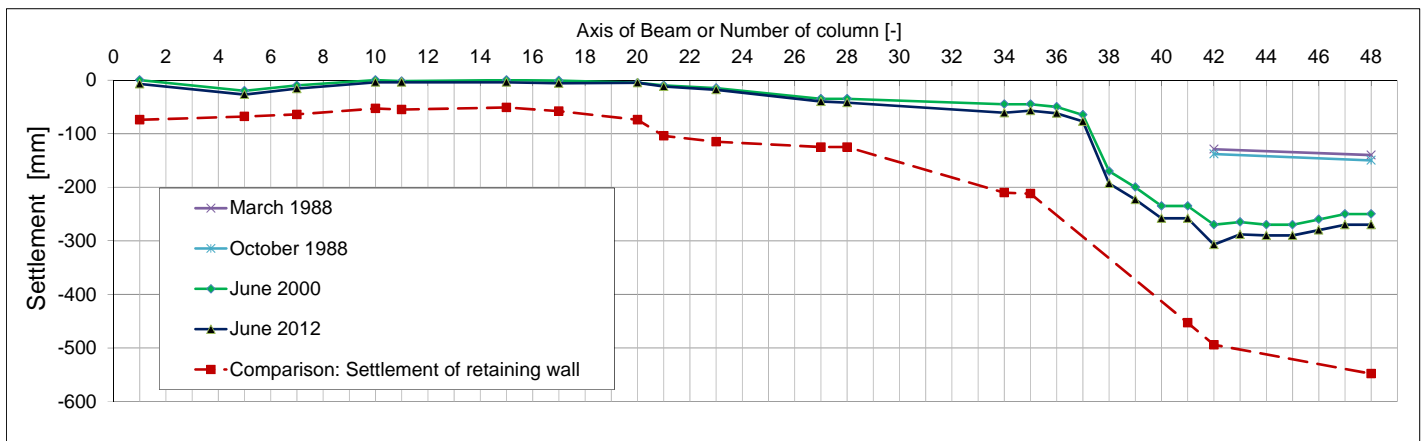
The settlement below the piles was relatively larger after 1990 than the settlements below the retaining wall. Based on these observations one has to assume that the stress redistribution in the deeper parts of the sediments has taken substantially longer. These measured settlements now correspond better to the settlements computed by elastic analyses. The analyses carried out in 1987 had resulted in an over-prediction by 50 % of the measured settlement, this difference has now decreased.

Fig. 9. Settlement of columns from 1986 until 2012 and comparison with retaining wall.

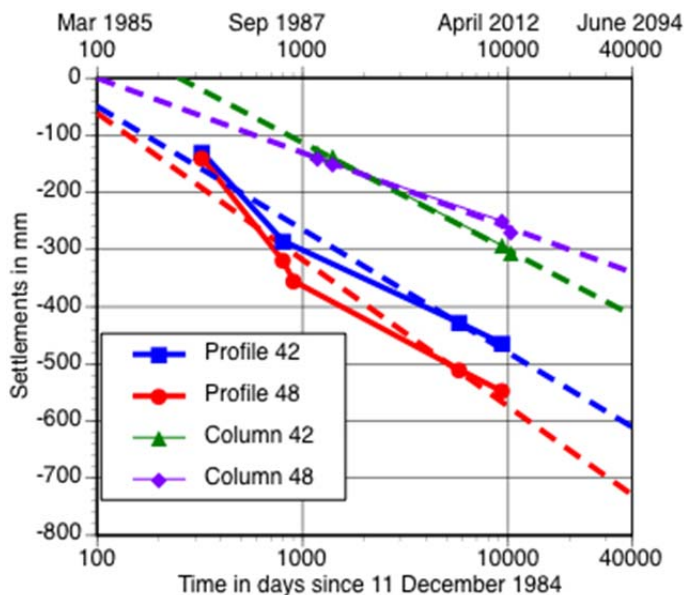
The observed settlements at the southern end in sections 42 and 48 have been analyzed and used to predict future settlements of the retaining wall (Fig. 10) in a logarithmic scale with time. The year 2012 corresponds to about 10000 days and 40000 days to the year 2094, roughly a century after construction. For 2094 a settlement of 720 mm is predicted for section 48, corresponding to another increment of 170 mm from 2012.

In section 42 additional settlements of 150 mm are predicted, thus reaching about 610 mm in 2094.

In section 48 the layer of silt is 44 m thick (Fig. 7) and in section 42 estimated as about 36 m. This results in a coefficient of secondary consolidation $c_s = 0.6\%$ per log cycle of days.

The rates of secondary settlement are smaller for the columns than below the retaining wall.

Fig. 10: Observed settlements of back wall and columns in section 42 and 48 and extrapolation.
