Assessment of the stability of a century-old water supply dam in north-central Pennsylvania

ABSTRACT: The Bradford No.3 Dam, located a few miles west of the City of Bradford, Pennsylvania, is a 47-foot high earth embankment that was constructed as a water supply impoundment in the late Nineteenth Century and is still used for that purpose today. Although the dam has served its purpose admirably over the past hundred years, its stability had not been formally evaluated nor had the potential for overtopping. This prompted a detailed assessment of the dam pursuant to upgrading the structure to meet state regulatory requirements. The consequent drilling and testing program to establish the types and properties of the embankment and foundation soils revealed soft zones within the embankment that were evidenced by Standard Penetration Test N-values near zero, accompanied by settlement of the drilling tools under their own weight. Difficulties experienced in procuring and testing representative “undisturbed” embankment samples prompted a program of dilatometer and borehole shear testing to more reliably define and characterize the soils. These in-place tests contributed greatly to a rati

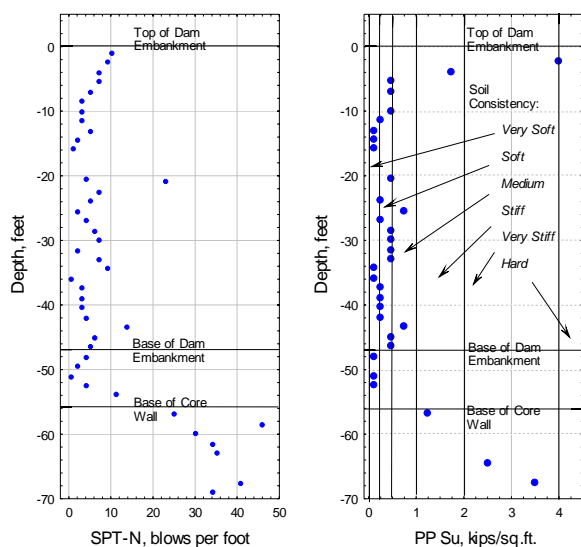
A representative profile of Standard Penetration Test N-values is presented in Figure 2. The N-value is defined as the number of blows required to drive a standard split barrel sampler a distance of 12 inches into the soil using a 140-pound hammer dropping through a height of 30 inches. Corresponding pocket penetrometer values are also presented in Figure 2. The penetrometer values provide a rough estimate of Q_u , the unconfined compressive strength, and in turn the undrained shear strength S_u of a cohesive soil.

Profiles of S_u estimates from the top-of-dam borings showed a predominance of soft to very soft material ($S_u \leq 0.5$ ksf). Mid-slope and toe borings showed a greater proportion of soils of medium consistency ($0.5\text{ksf} \leq S_u \leq 1\text{ksf}$). On the basis of the penetrometer tests, the mean value of S_u was found to be 0.59 ksf, and the median value, 0.5 ksf.

Figure 2 Profiles of Standard Penetration test N-values (left) and Pocket Penetrometer Estimates of undrained Shear Strength (right) for Top-of-Dam Test Borings B-3-1 and B-3-1A (combined)

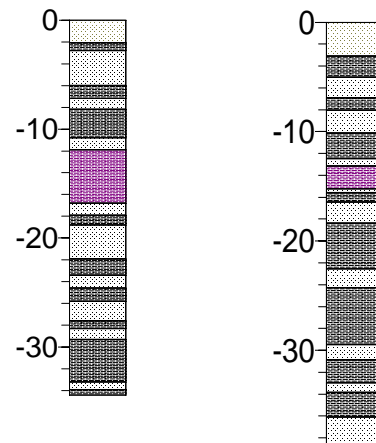
Figure 4 Soil Layering Delineated by Top-of-Dam Dilatometer Soundings D-3-1 (left) and D-3-2 (right). Light-toned layers are cohesionless soils; dark-toned layers are cohesive soils. Vertical axis is in feet.

- Soil Layers. Cohesive layers within the dam embankment alternate with cohesionless layers. The cohesive layers were found to range from 0.5 feet to 5 feet in thickness, and to average 2 feet. The cohesionless layers were found to range from 0.35 to 3.2 feet in thickness, and to average 1.6 feet (Figure 4). No correlation of layers is evident between soundings. The layering is thought to reflect the construction methods used a century ago when horse and mule-drawn equipment was used to place the embankment fill (Figure 5), and rudimentary pavements of cohesionless soils were alternated with soft, low permeability cohesive soils to enable the construction equipment to cross the embankment without bogging down. The dilatometer soundings indicate that the embankment consists of approximately 56 percent cohesive soils and 44 percent cohesionless soils.

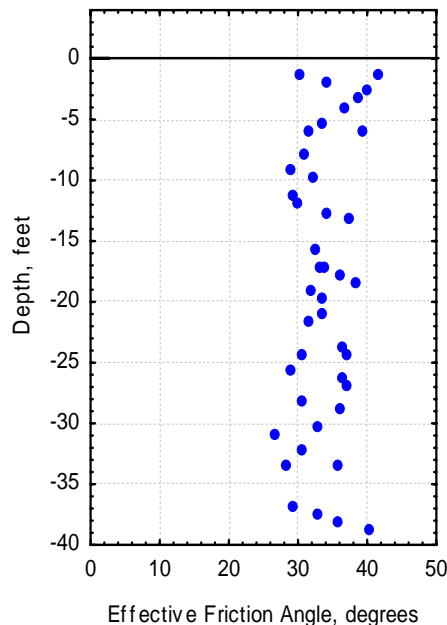
- Effective Friction Angle of Cohesionless Soil Layers. The drained friction angle was found to range between 26 and 42 degrees, with a mean value of approximately 34 degrees (Figure 6). These values are based on the correlation of Marchetti presented in ISSMGE (2001):

Figure 6 Profile of Effective (Drained) Friction Angle Values for the Cohesionless Soil Layers as determined from dilatometer soundings

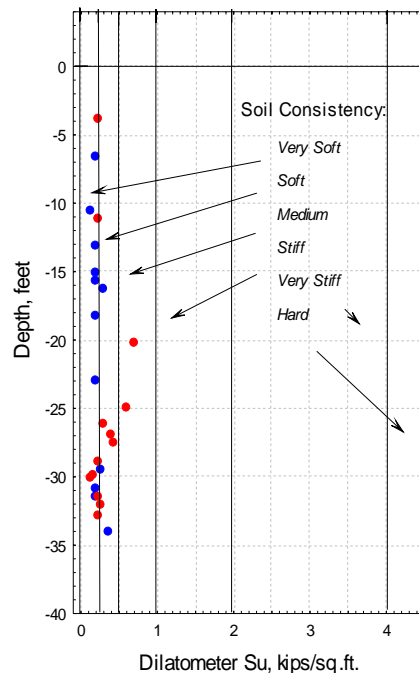
$$N_{safe,DMT} = 28^\circ + 14.6^\circ \log K_D - 2.1^\circ \log^2 K_D,$$
 where K_D is the horizontal stress index.
- Undrained Shear Strength of Cohesive Layers. S_u values of the cohesive layers ranged from 0.15 ksf to 0.7 ksf. The mean value was ap-

proximately 0.28 ksf (Figure 7). These values are based on the correlation of Marchetti (1980):

Figure 7 Profile of Undrained Shear Strength Values for the Cohesive layers as determined from dilatometer soundings

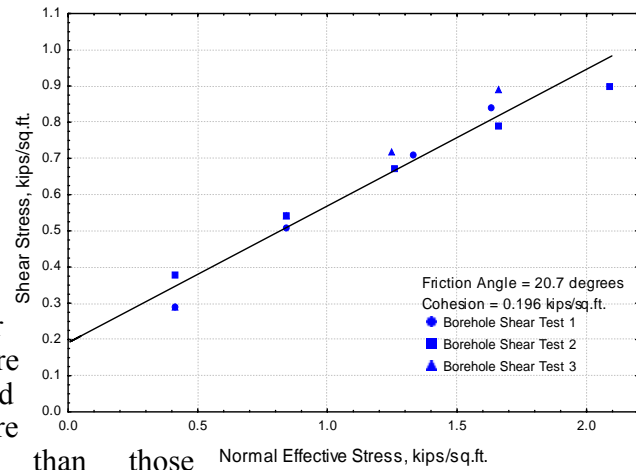
- All three borehole shear tests, which were performed at depths of 10 ft., 15 ft., and 30 ft. below the top of dam and within intervals identified by dilatometer testing to be cohesive, yielded similar results.
- These three tests yielded values of effective friction angle between 17.2 and 25.2 degrees and cohesion between 0.122 and 0.269 ksf. Taken together, these tests suggest an effective friction angle of 20.7 degrees and an effective cohesion of 0.196 ksf to be representative of the cohesive soils (Figure 9).

Figure 9 Mohr Envelope developed from Borehole Shear Testing conducted in cohesive soil intervals within top-of-dam borings
