AN EXAMPLE OF USE OF DMT AS AN HELP FOR EVALUATING COMPACTION OF SUBGRADE AND UNDERLYING EMBANKMENT

by S. Marchetti
Internal Technical Note

Oct 1994 draft

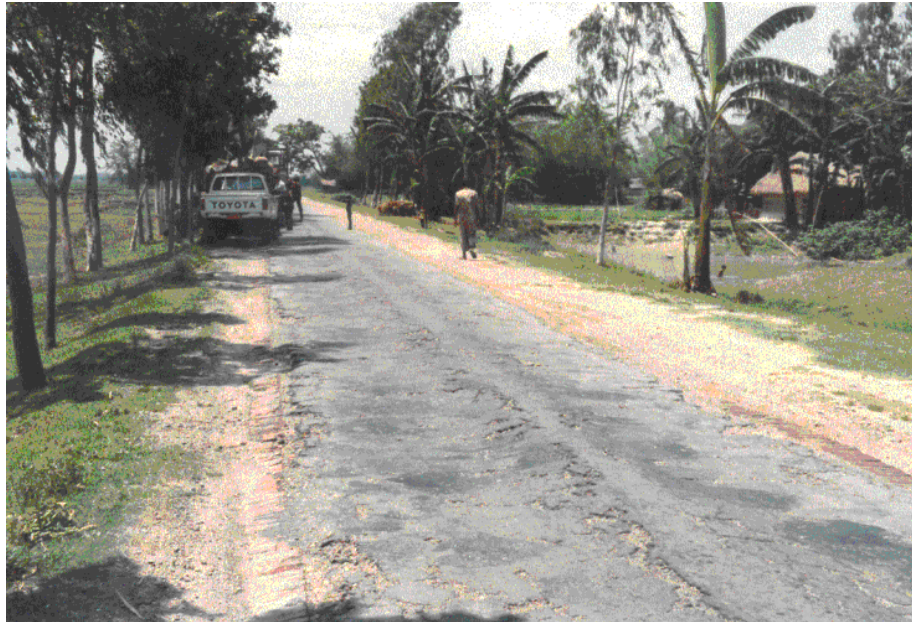
**Fig. 1 – Old road. At center the damaged pavement.
Laterally the two unpaved shoulders.**

-Rehabilitation of the road Dinajpur-Panchagarh (93 km), Bangladesh. Client : Italian Ministry of Foreign Affairs - Office of International Cooperation. Designer : Sauti (Roma-Italy). Contractor : Bonatti (Parma-Italy). The road was initially built in the 1950s. Presently the paved surface appears severely damaged (Fig. 1) due to differential settlements of the underlying poorly compacted loose silt composing the embankment. The silt of the embankment was excavated from the adjacent ground surface, and therefore is the same soil as the foundation.

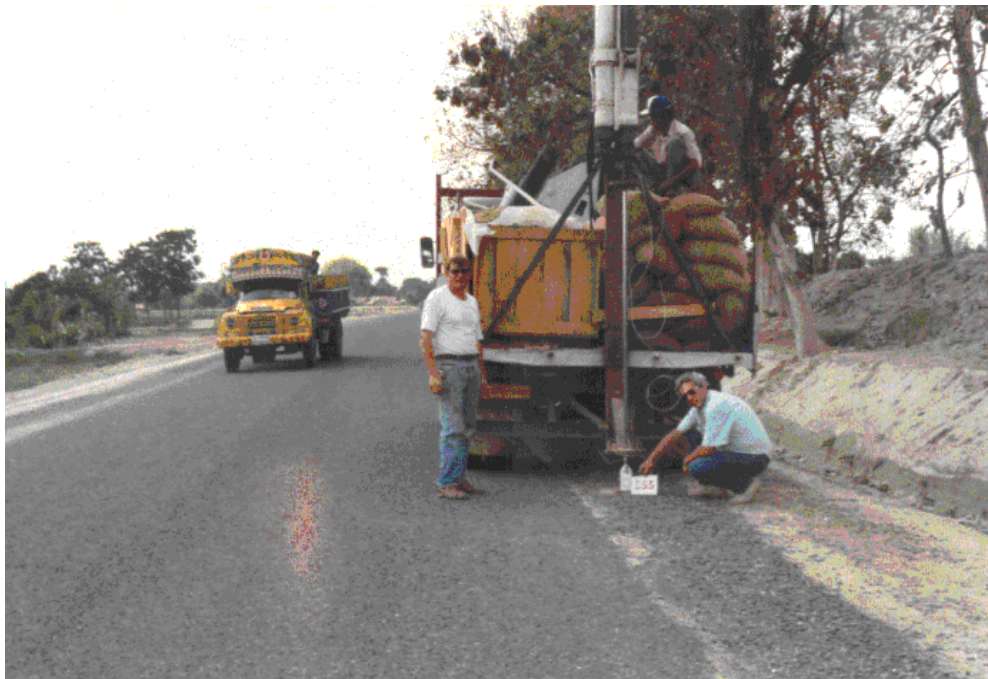
**Fig. 3 – Truck mounted penetrometer used for pushing
the dilatometer blade**

Period : April-May 1993. Generally 1 sounding every km. Depth mostly 4m, depth interval 10 cm. Production : 12-15 soundings per day. The dilatometer tip was pushed by a 10 ton (100 KN) truck-mounted penetrometer (Fig. 3). Special very high strength tips were used (rated failure load 50 ton= 500 KN) to penetrate directly, when possible, the superstructure, thus avoiding holes. However no tests were performed, obviously, in the superstructure.

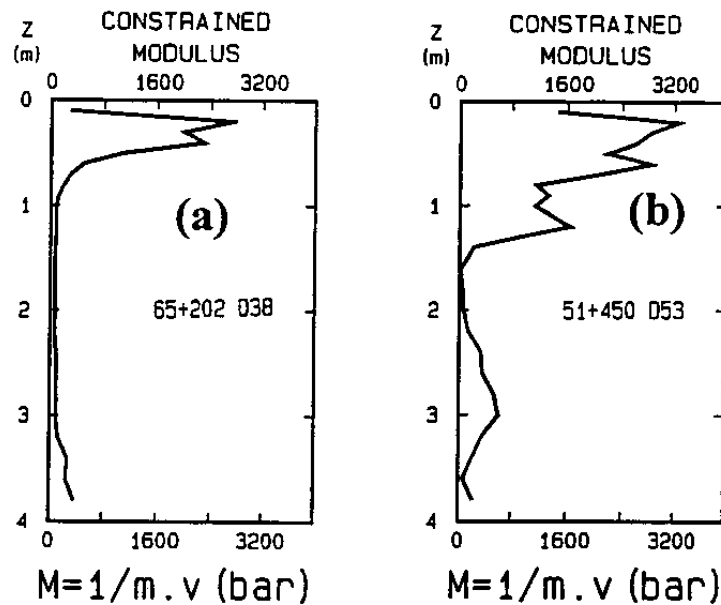
Fig. 5 - M profiles before/after compaction from two representative soundings.
(a) D38 : from shoulder of old road (uncompacted)
(b) D53 : from top of subgrade - Category 4 compacted according to specifications

1. The DMT results in the old road (Fig. 5a) confirm that the silt of the old embankment is generally very loose (M≈40-120 bar), even looser than the original silt in the foundation.

Traffic and desiccation have however produced a crust ($M \approx 500-2400$ bar) extending to a depth of 70-80 cm below the surface of the old road.

2. Soundings performed in the accepted subgrade yielded systematically profiles similar to that in Fig. 4b-categories 3 and 4 and Fig. 5b, with M reaching a maximum of 2400-2800 bar typically at 25 cm depth. This result appears to support the existence of relationships between DMT moduli and density and/or CBR (Borden et al. 1985, 1986, Schmertmann 1988) and the potential of using M from DMT as an economical supplementary subgrade acceptance tool. For the latter scope one could develop, in the initial stages of the works, a "minimum acceptable M profile" similar to the one in Fig. 4b-Category 3, based on a series of DMTs on the accepted subgrade, then use such M profile as a subgrade acceptability benchmark.
