Long-Term Settlements of an Avalanche Gallery on Loose Soil

ABSTRACT: An avalanche protection gallery built 1984 to 1985 on the Gotthardpass road in the central Swiss Alps suffered substantial settlement of several decimeters. The causes were determined by additional site investigations during 1987 utilizing the Marchetti Flat Dilatometer DMT (Steiner, 1994). Since construction 30 years have passed and the road and its structures have undergone a complete inspection and will be reconditioned. Within this long-term maintenance project the settlement behavior of the avalanche gallery has been reevaluated and the monitored settlements have been compared to the prediction from 1987. The settlement and deformations have followed a semi-logarithmic law with time, but differential settlements have changed. The value of the DMT measurements can be confirmed by these long-term measurements.

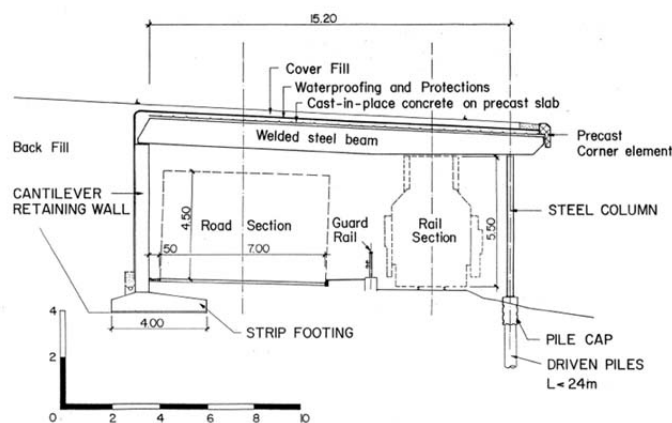
The structure of the avalanche gallery, shown in cross section in Fig. 1, is formed by a cantilever retaining wall on the mountainside and columns supported by driven piles on the side of the valley. Steel beams (Fig. 2) span over both railroad and road. Between the steel beams precast element covered by cast-in-place concrete complete the roof. The concrete slab is covered by a membrane (Fig. 1) overlain by a protective layer.

Fig. 1. Cross section of avalanche protection gallery.

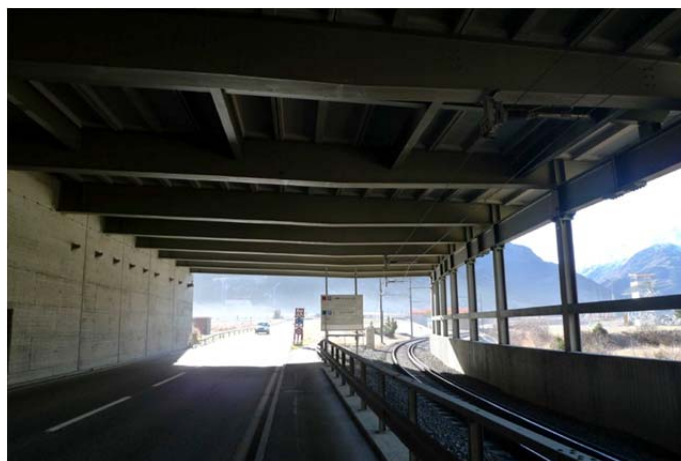
Fig. 2. View of the southern end of the avalanche gallery in 2011 with retaining wall on left with heads of tieback.

A few years after construction of the avalanche gallery a major flood had occurred and the river nearly reached the level of the road. In order to prevent flooding in case of future catastrophic events a floodwall was constructed incorporating columns (Fig. 2).

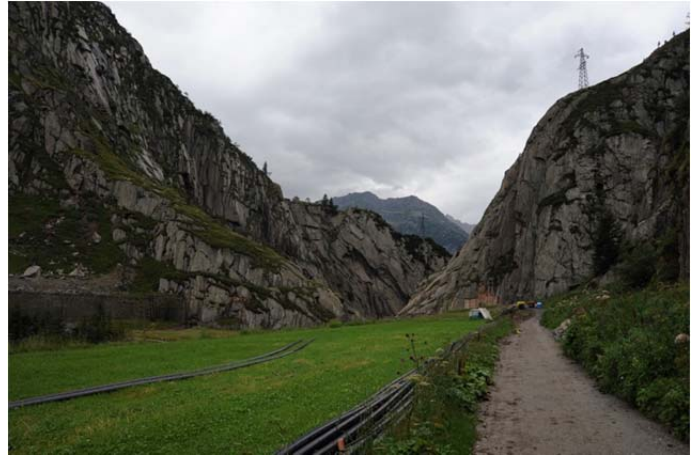
Fig. 5. View over the roof of the avalanche protection gallery with the rock ridges at the gorge to the north.

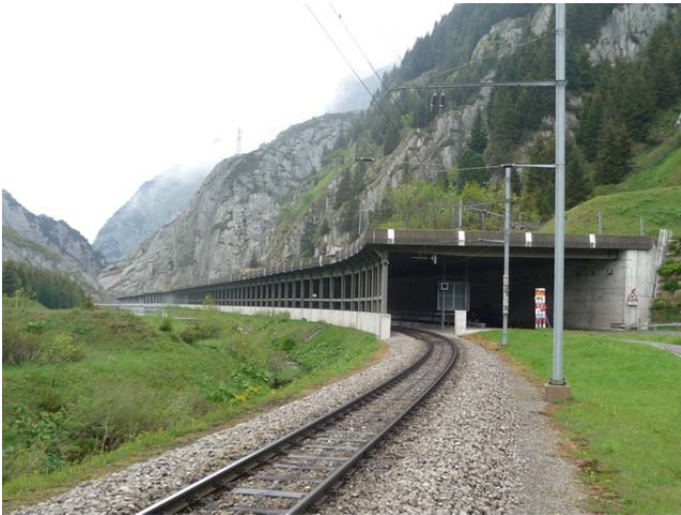
Fig. 3. Avalanche gallery seen from the south towards the ridge above the Schöllenen gorge in 2011.

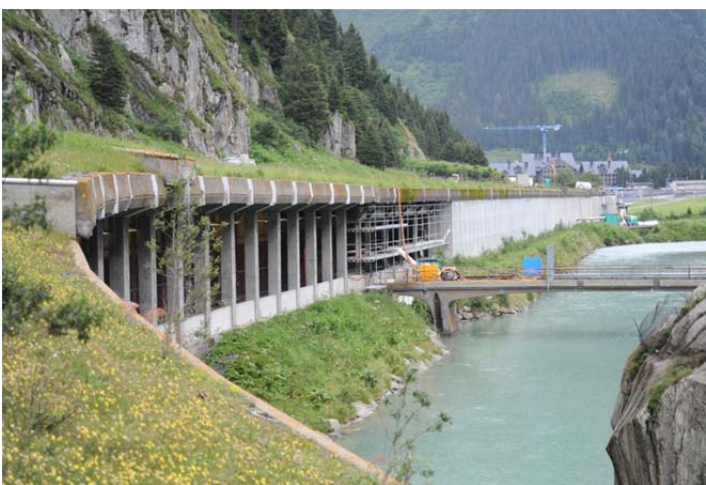
Fig. 4. Avalanche protection gallery as seen from the roof of the northern railway gallery founded on rock near natural and artificial weir above the Schöllenen gorge.
